Replacement Master Plan

Gull Lake Dam

Prepared for
Gull Lake Association

May 2018

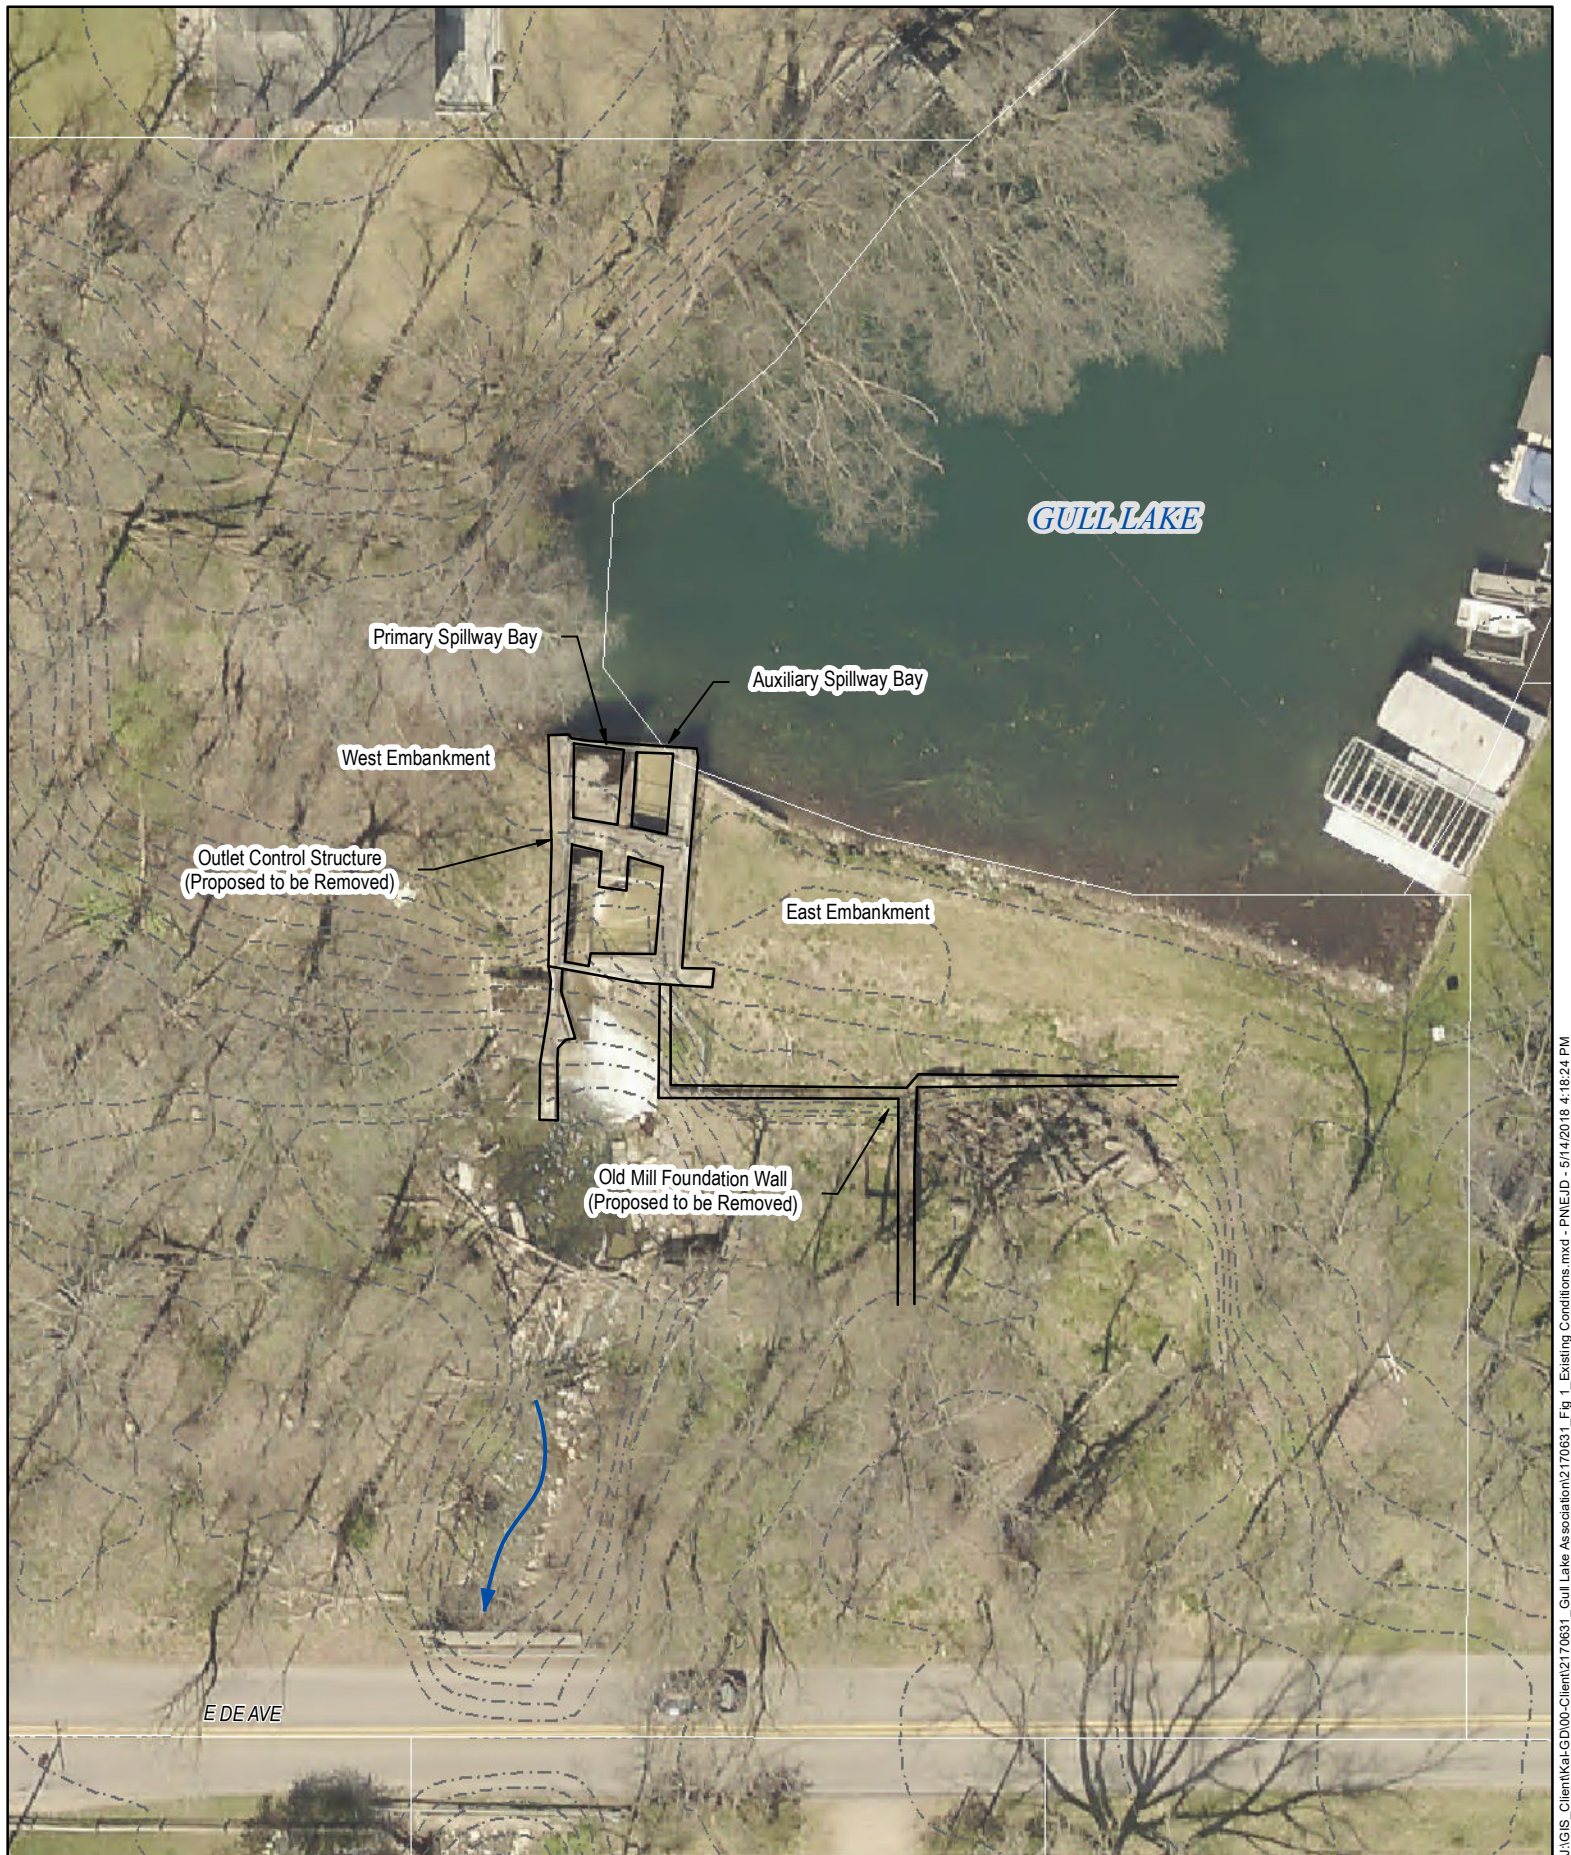
Figure 1. Existing Conditions

- Physical and mechanical processes such as cracking due to freezing and thawing or wetting and drying cycles. Numerous cracks, spalls, and loss of concrete were observed throughout the spillway. With repair, these components may last an additional 10-20 years. Other portions of the dam, such as the right downstream abutment wall, have deteriorated beyond repair and are assumed to be at their useful life.

- Chemical processes such as oxidation of metal components within the gate house.
- Biological processes such as growth of plants in cracks.
- Seepage under the foundation or through the embankment. Seepage was observed at the toe of the concrete wall on the left downstream toe of slope and will continue to progress and increase the uplift pressure on the wall and toe over time and increasing the risk for failure. Therefore, we believe the embankment has reached its useful life.

First, fully remove the old mill foundation wall. Seepage was observed along the bottom of the old mill foundation wall on the east side (left) of the spillway. The design of the wall, including depth and presence of footings, is unknown. It is evident that the wall is not deep enough to cutoff seepage and hydraulic pressure will continue to increase behind the wall. Therefore, we recommend full removal of the old mill foundation wall.
