Dam Safety Inspection Report

Gull Lake Dam No. 565

Inspection Date:	April 1	3, 201	8
Report Date:	April 1	3, 201	8

Project Number 2170631

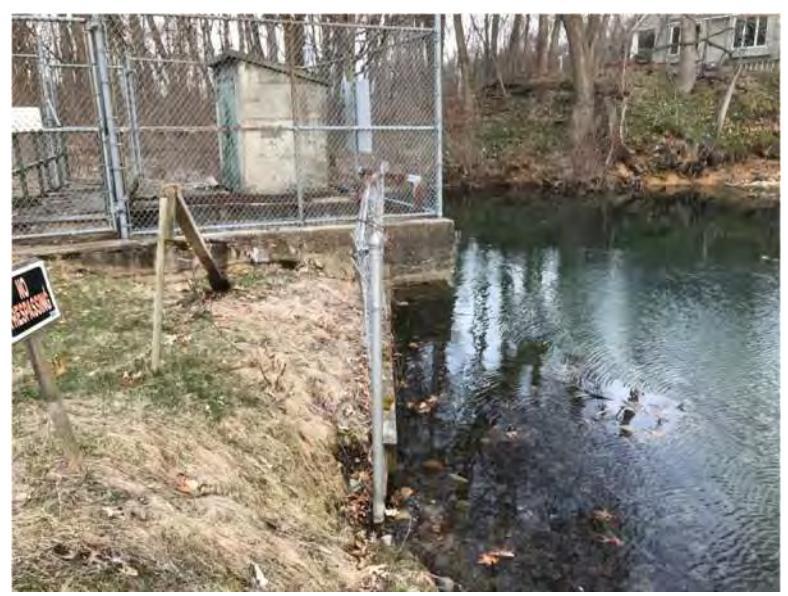
Fence at left embankment. Some settlement or loss of embankment behind fence.

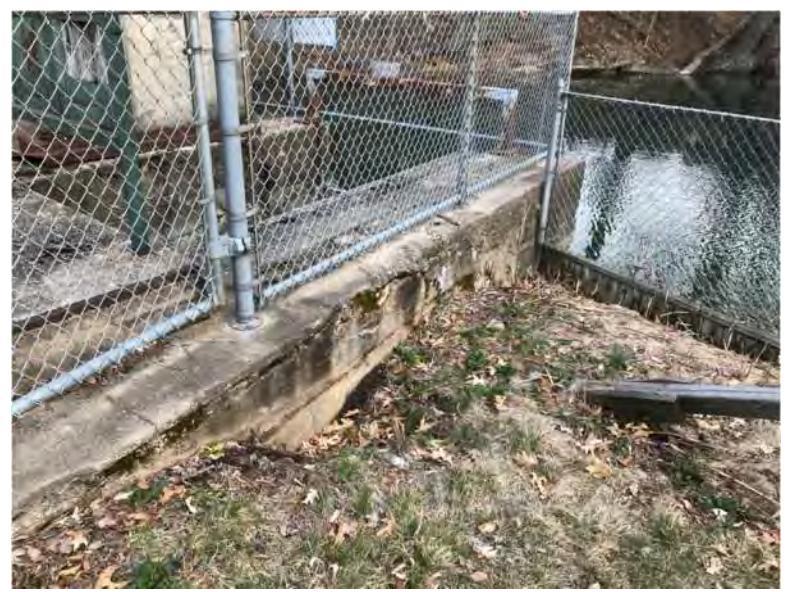
Cracks and spalling in left upstream spillway wall

Recommendation: At a minimum, monitor these areas for any potential movement. Patch existing cracks and spalls at the top of the spillway walls with grout. Remove any existing loose concrete prior to patching.

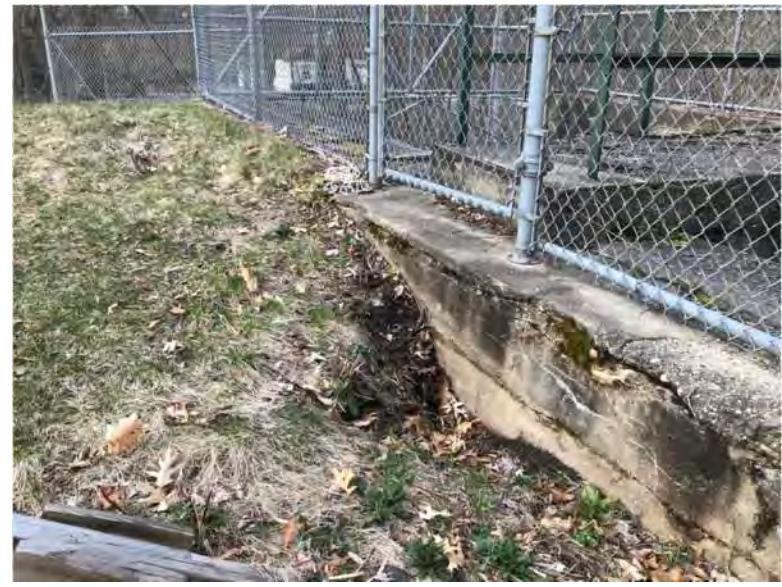
2. *Observation:* There are two sinkholes on the left embankment crest and upstream face adjacent to the spillway abutment wall. These sinkholes may be the result of surface erosion or animal burrows or may be caused by piping through the embankment along the

spillway wall. The seepage at the downstream toe of this spillway wall and two in-line sinkholes are an indication that piping may be occurring through the embankment at this location.

Sinkhole adjacent to left upstream spillway wall

Recommendation: Fill sinkholes with additional soil material and seed. Monitor locations for additional settling. Any increase in settling should be brought to the attention of a qualified engineer and/or MDEQ Dam Safety Unit. Piping along the spillway wall has the potential to mobilize embankment materials and destabilize the dam. Failure can occur rapidly or take place over several months or years depending on embankment materials and hydraulic loading. The owner should regularly monitor and observations and photographs should be kept and reviewed as needed.

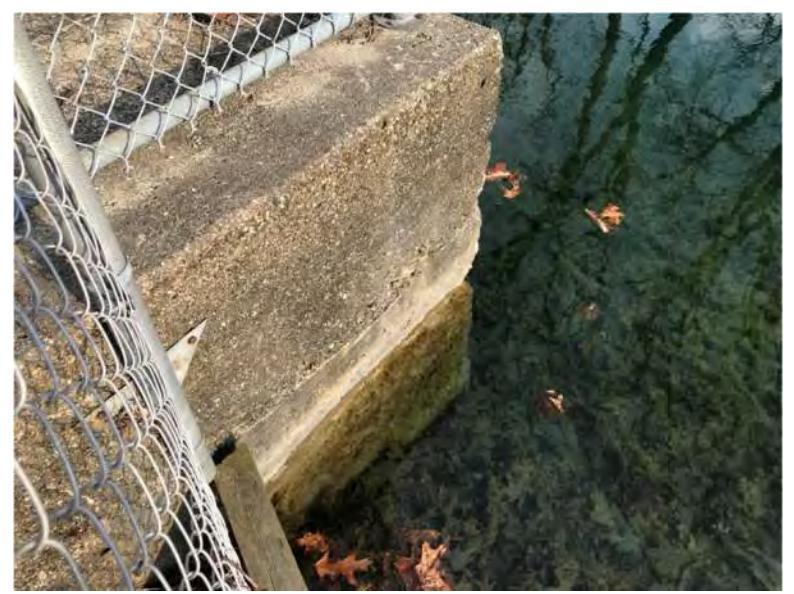
Loss of concrete on upstream end of left spillway wall

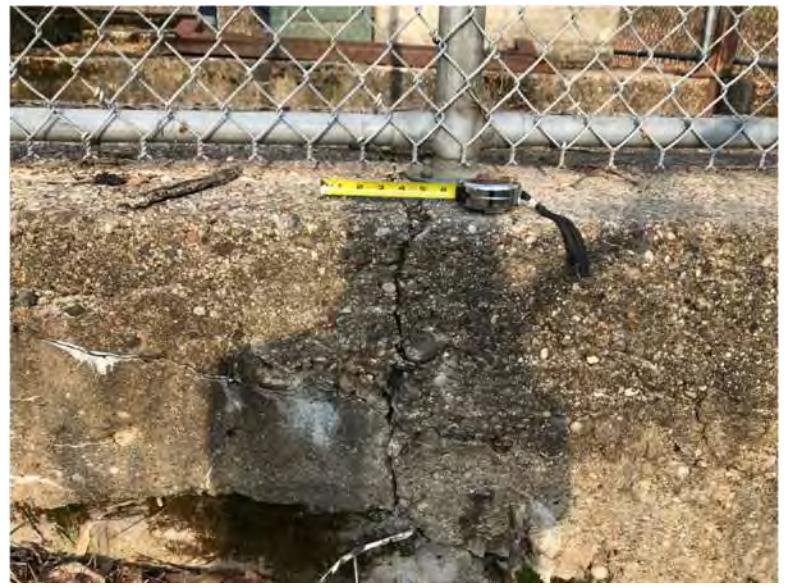
Crack in upstream end of left spillway wall

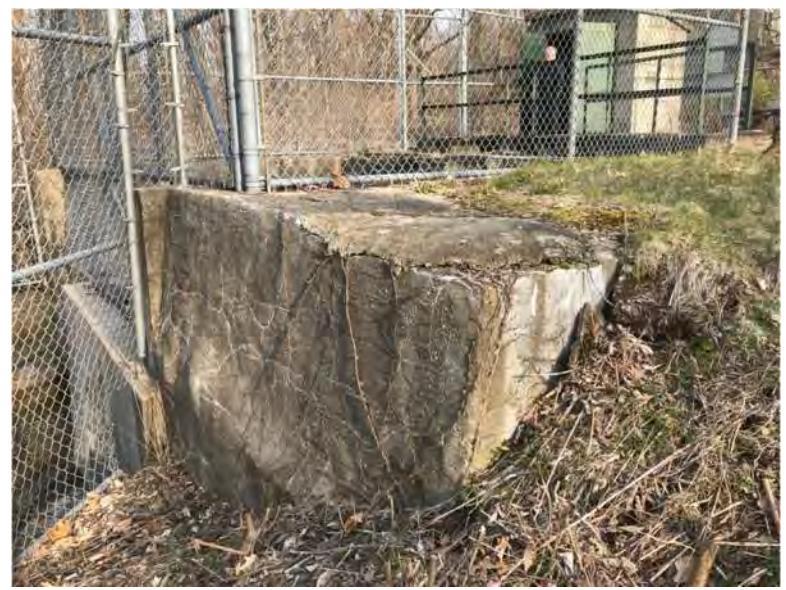
Cracks and spalling in downstream end of left spillway wall

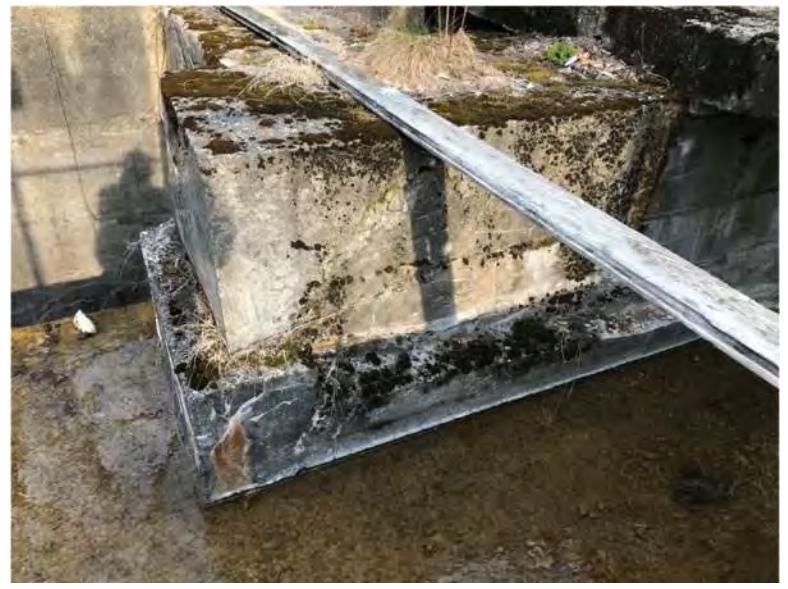
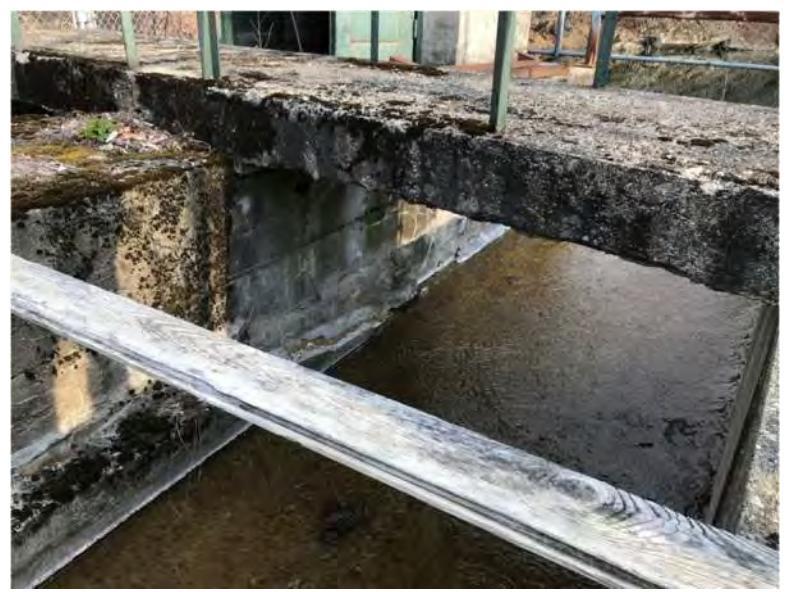
Cracks, efflorescence, and loss of concrete in center spillway wall

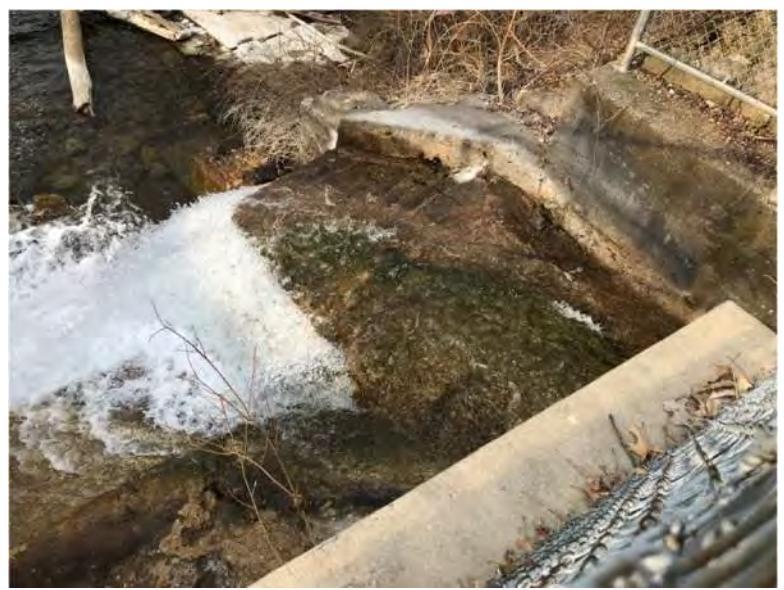
Right downstream face of principal spillway. Note crack

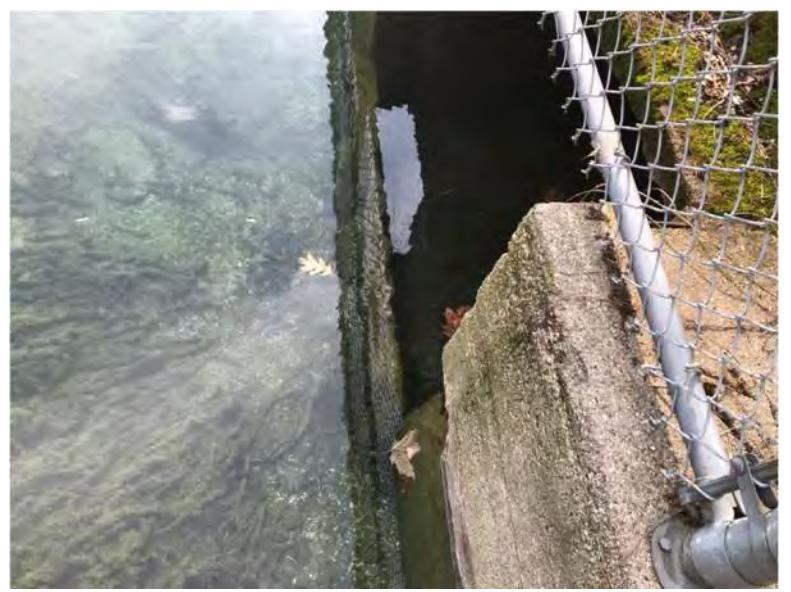
Loss of concrete at right upstream spillway wall

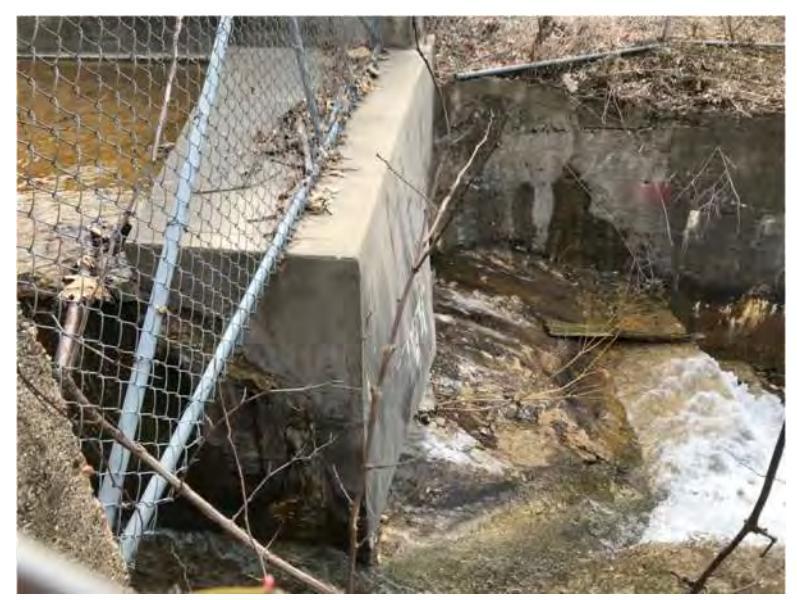
Downstream face of spillway. Note loss of concrete in foreground and seepage in background.

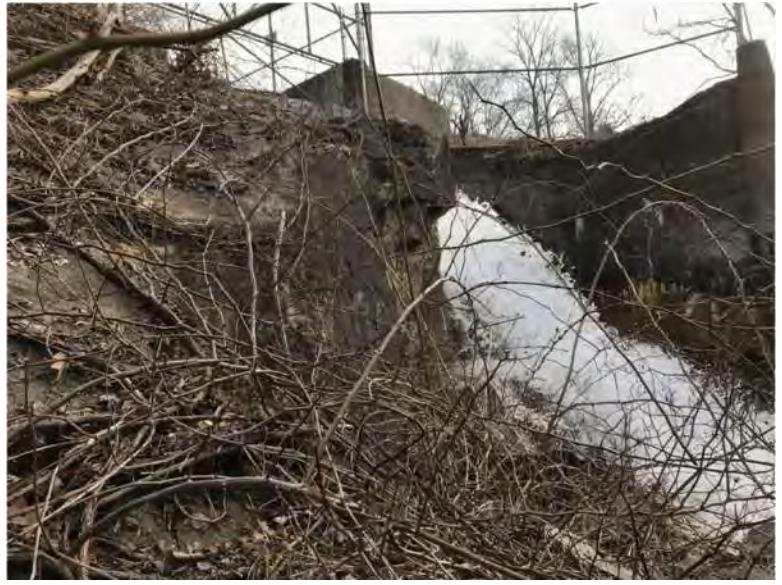
South end of right downstream spillway wall. Note loss of concrete.

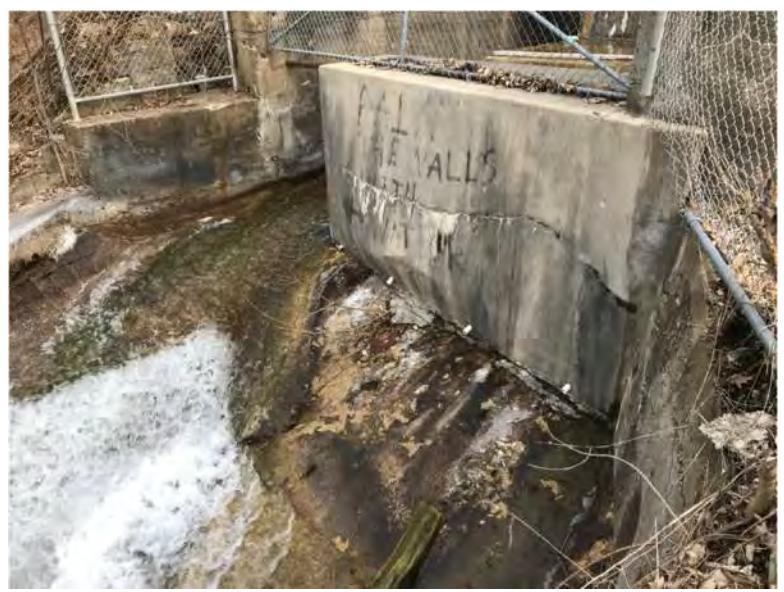
- Observation: There is a tree growing through the south facing wall between the principal and auxiliary spillways. *Recommendation:* Remove this tree and spray the stump with growth inhibiting herbicide. Monitor this location for any further vegetation growth.

Downstream face of spillway wall. Note tree at base of wall.

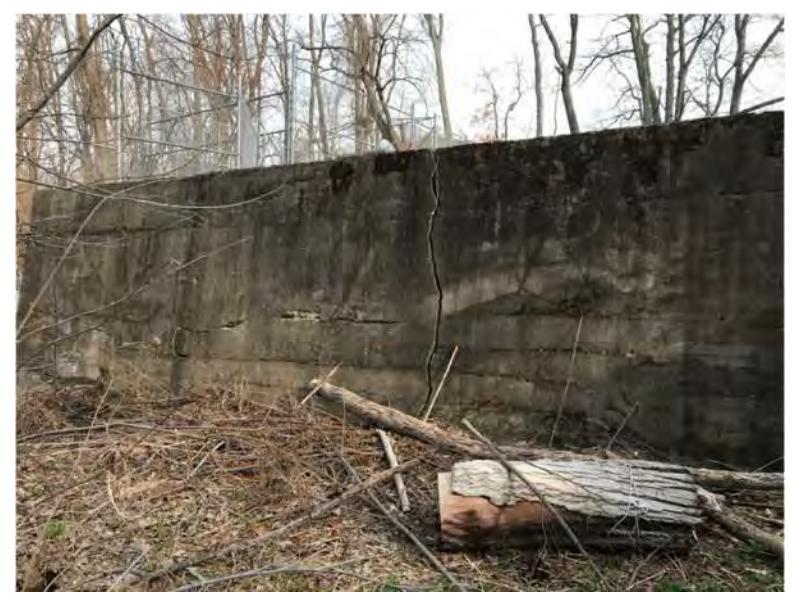
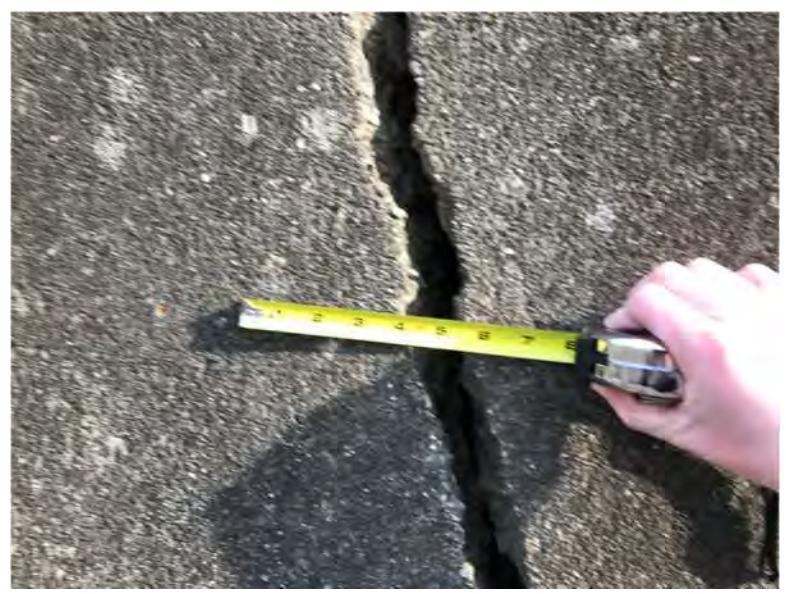
- 4. Multiple cracks and spalls were observed in the vertical concrete wall at the left downstream toe of slope. A 1.75" wide crack running the entire height of the wall was observed but does not appear to have changed since the 2013 inspection.

Vertical crack in left downstream embankment wall

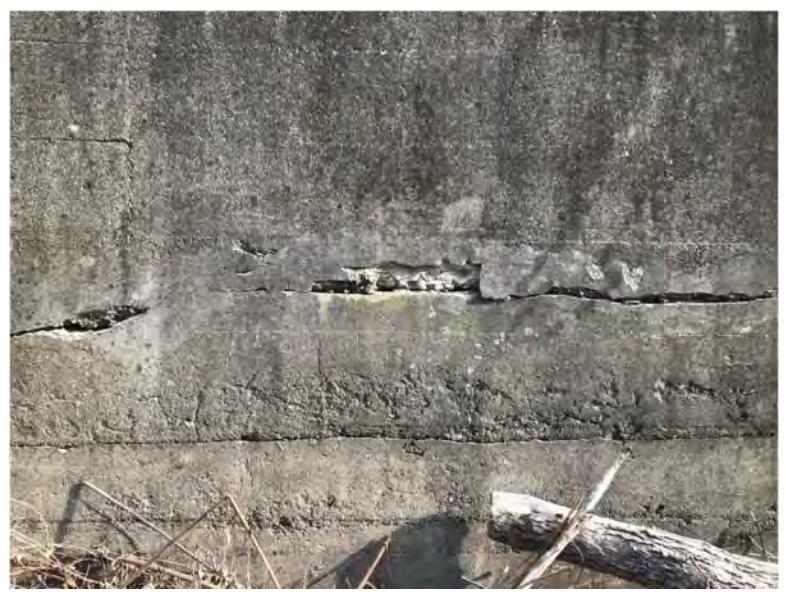
Spalling and loss of concrete in left downstream embankment wall

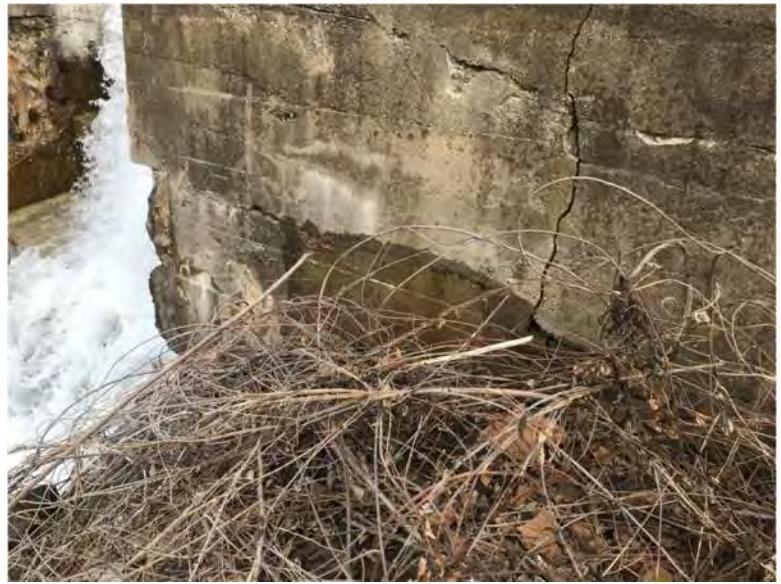
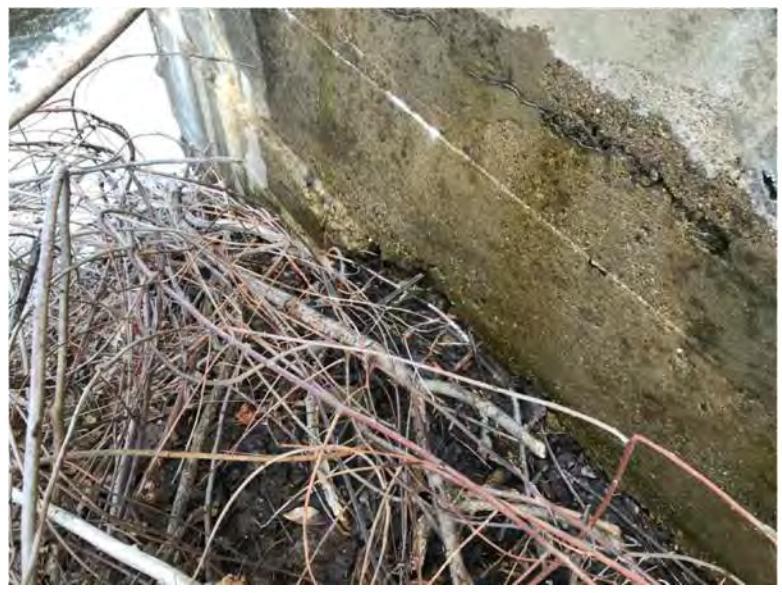
Observation: Seepage was observed along the exterior of the left inside edge of the old mill foundation wall (See Figure 1 in Field Notes). There is loss of earthen material and concrete at this location. Water appeared to be dripping from an exposed edge of the concrete wall. The seepage was clear at the time of the inspection and no signs of sediment transport were observed. Additional seepage was observed in the inside face of the left spillway wall near the bottom of the tailrace.

Seepage at base of left downstream spillway wall

Recommendation: Monitor these locations for an increase in seepage flow rate and additional loss of earth or concrete material. Any increase in flow rate or loss of material should be brought to the attention of a qualified engineer and/or MDEQ Dam Safety Unit. Continue to monitor the exterior of the right spillway wall for the seepage observed during the 2013 inspection. A monthly log of observations and photographs should be kept and reviewed as needed.

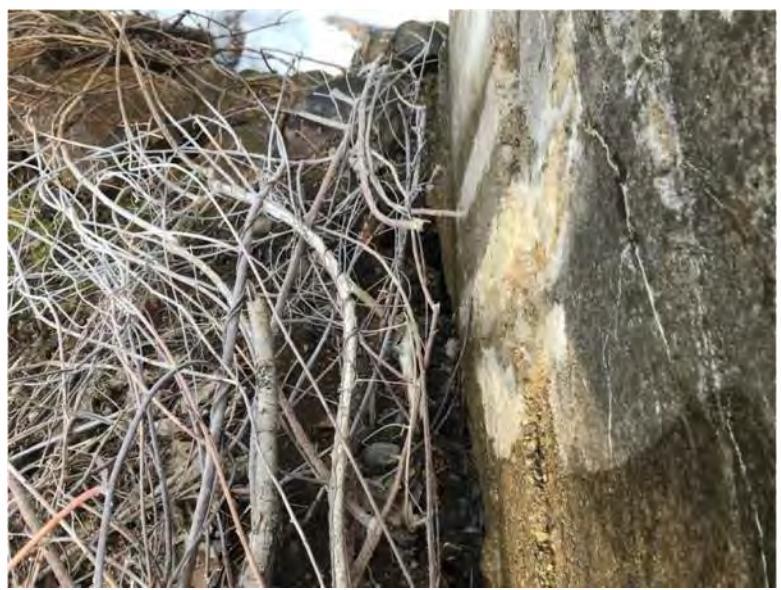
Seepage and efflorescence at base of left downstream spillway wall
